**Flood Control Project Maintenance
Levee Inspections**

Maintenance Issue Types Only, Levee Inspection Report By Mile - Fall 2015

Reclamation District No. 2060 Hastings

Waterway	Bank	Unit Miles	Inspection Start/End	Inspector
Unit No. 01 Lindsey Slough	Left	6.97	11/03/2015 11/03/2015	Herman Phillips

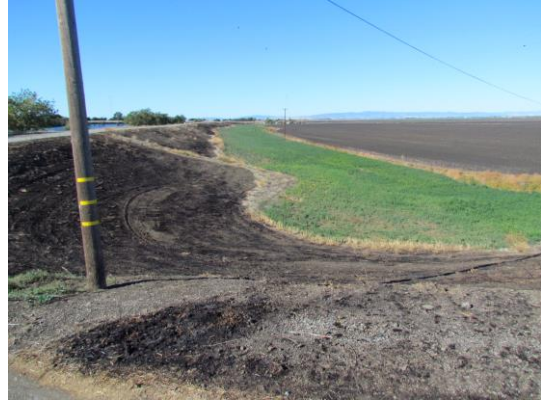
Photo 1 of 1 : FA_2015_RD2060_241_3_20151103_00002.jpg

LM Start	0.00	Rating **	A	Issue No.	3
LM End	1.54	Issue Type +	Ma	Location *	LS
Category	Earthen Levee			GPS Latitude/Longitude	
				Start	End
Item	Vegetation			38.247345 °	38.252453 °
				-121.696287 °	-121.722590 °
DWR ID	DWR_RD2060_01_f_2015_3				
Action/Comments					
Control annual grass and weeds on the levee slopes and easements. Inspector Comments: The District has burned the landside levee slope where possible in this area.

RD 2060 Landside levee slope from levee mile 0.00 looking downstream.

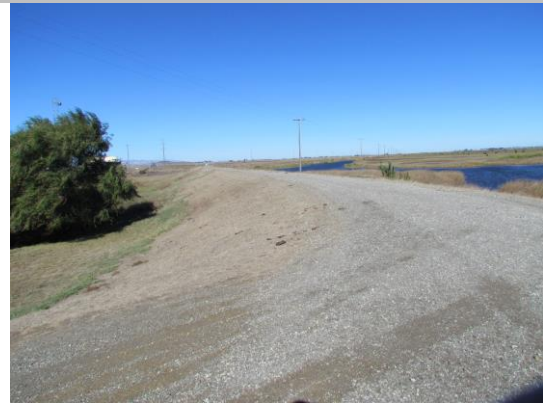
Photo 1 of 1 : FA_2015_RD2060_242_9_20151103_00006.jpg

LM Start	0.07	Rating **	A	Issue No.	9
LM End	3.64	Issue Type +	Ma	Location *	WS
Category	Earthen Levee			GPS Latitude/Longitude	
				Start	End
Item	Vegetation			38.275780 °	38.296648 °
				-121.795488 °	-121.748765 °
DWR ID	DWR_RD2060_02_f_2015_9				
Action/Comments					
Control annual grass and weeds on the levee slopes and easements. Inspector Comments: No unwanted weeds present during this inspection.

RD 2060 Looking downstream from the waterside levee slope levee mile 0.07 Unit 2.

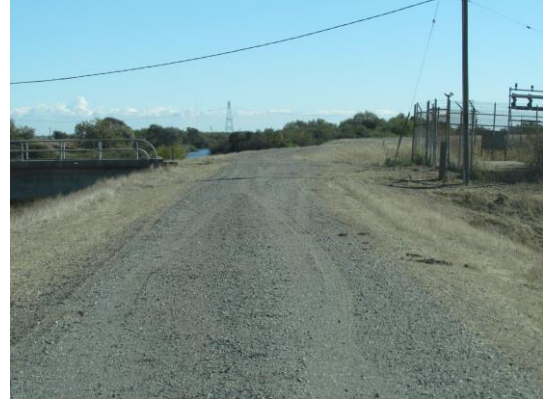
Photo 1 of 1 : FA_2015_RD2060_243_14_20151103_00011.jpg

LM Start	0.00	Rating **	A	Issue No.	14
LM End	5.02	Issue Type +	Ma	Location *	LS
Category	Earthen Levee			GPS Latitude/Longitude	
				Start	End
Item	Vegetation			38.296648 °	38.247523 °
				-121.748765 °	-121.696232 °
DWR ID	DWR_RD2060_03_f_2015_14				
Action/Comments					
Control annual grass and weeds on the levee slopes and easements. Inspector Comments: No unwanted weeds present on the landside levee slope.

RD 2060 Unit 3 looking downstream from levee mile 0.00 landside.

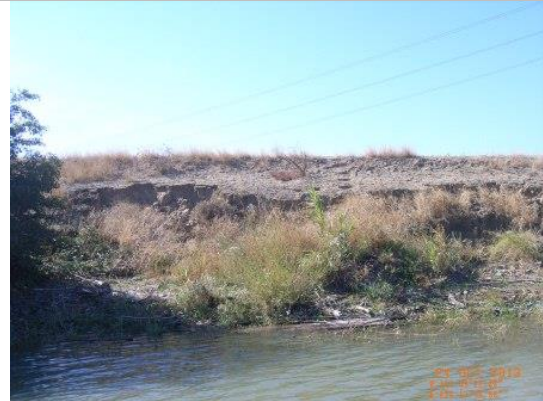
Photo 1 of 1 : USACE2013A_CHS_23-6_R_2.jpg

LM Start	1.52	Rating **	M	Issue No.	8
LM End	1.74	Issue Type +	Ma	Location *	WS
Category	Supplemental			GPS Latitude/Longitude	
				Start	End
Item	2015 USACE Erosion Survey, DRAFT			38.288598 °	38.286051 °
				-121.725184 °	-121.722818 °
DWR ID					
Action/Comments					
Inspector Comments: Site added in 1997 and removed in 2003. 2005 - Put back in the inventory. 2006 - Stone repair at the middle of the site. 2011 - Some rock place at toe in the past year. 2013 - Site extended both upstream and downstream to include new erosion pockets. 2015: No observed changes. [2015 Site ID: CHS_23-6_R]

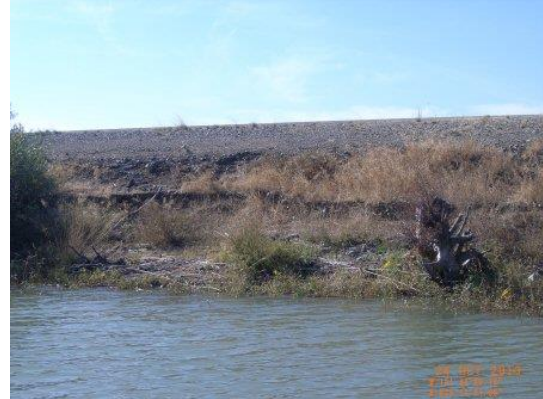
Photo 1 of 1 : USACE2013A_CHS_23-0_R_1.jpg

LM Start	2.02	Rating **	M	Issue No.	1
LM End	2.08	Issue Type +	Ma	Location *	WS
Category	Supplemental			GPS Latitude/Longitude	
				Start	End
Item	2015 USACE Erosion Survey, DRAFT			38.284105 °	38.283302 °
				-121.718471 °	-121.717814 °
DWR ID					
Action/Comments					
Inspector Comments: 2010 - Small maintenance site. 2015: No observed changes. [2015 Site ID: CHS_23-0_R]

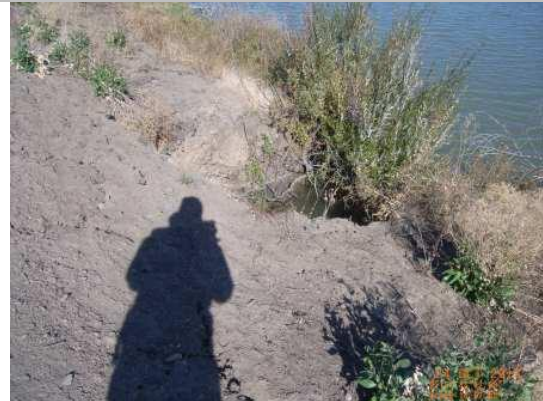
Photo 1 of 1 : USACE2013A_CHS_22-9_R_1.jpg

LM Start	2.12	Rating **	M	Issue No.	6
LM End	2.17	Issue Type +	Ma	Location *	WS
Category	Supplemental			GPS Latitude/Longitude	
				Start	End
Item	2015 USACE Erosion Survey, DRAFT			38.282880 °	38.282277 °
				-121.717487 °	-121.716996 °
DWR ID					
Action/Comments					
Inspector Comments: 2013 - Pockets of erosion behind willows. 2015: No observed changes. [2015 Site ID: CHS_22-9_R]

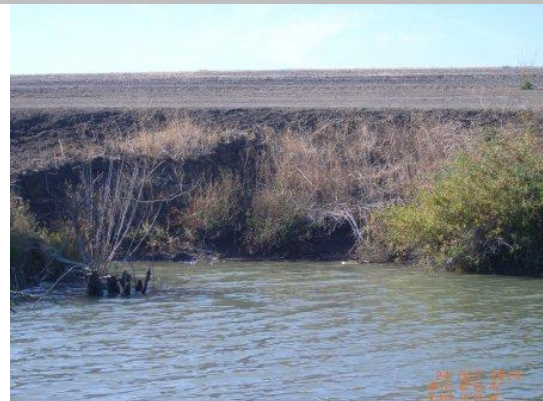
Photo 1 of 1 : USACE2013A_CHS_22-8_R_4.jpg

LM Start	2.18	Rating **	M	Issue No.	7
LM End	2.23	Issue Type +	Ma	Location *	WS
Category	Supplemental			GPS Latitude/Longitude	
				Start	End
Item	2015 USACE Erosion Survey, DRAFT			38.282100 °	38.281510 °
				-121.716817 °	-121.716319 °
DWR ID					
Action/Comments					
Inspector Comments: 2007 - Geotechnical failure of midside slope and wave wash/scalloping in toe area. Stone revetment upstream and downstream of site. Similar sites are present all along the right bank downstream of this site, most could be repaired with some maintenance. 2010 - Minor new erosion. 2015: No observed changes. [2015 Site ID: CHS_22-8_R]

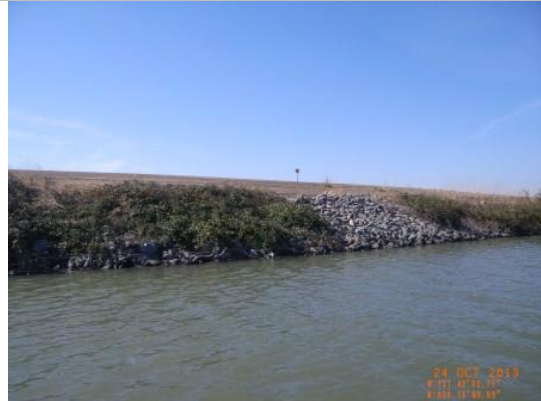
Photo 1 of 1 : USACE2013A_CHS_22-6_R_2.jpg

LM Start	2.35	Rating **	M	Issue No.	4
LM End	2.53	Issue Type +	Ma	Location *	WS
Category	Supplemental			GPS Latitude/Longitude	
				Start	End
Item	2015 USACE Erosion Survey, DRAFT			38.280377 °	38.278306 °
				-121.714633 °	-121.712722 °
DWR ID					
Action/Comments					
Inspector Comments: 2008 - Small scour pockets and mid-slope wave wash. 2010 - More vegetation growth, could be fixed through maintenance. 2011 - Site extended downstream and new erosion. 2015: No observed changes. [2015 Site ID: CHS_22-6_R]

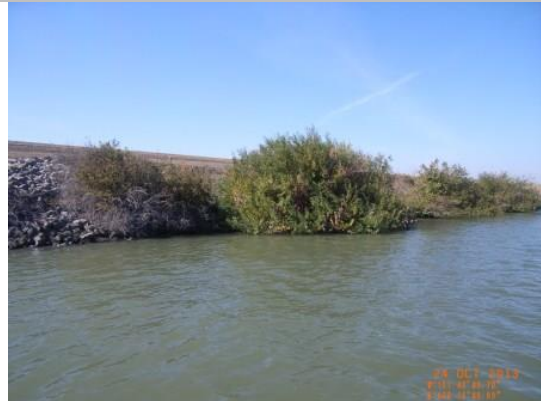
Photo 1 of 1 : USACE2013A_CHS_22-5_R_1.jpg

LM Start	2.55	Rating **	M	Issue No.	5
LM End	2.58	Issue Type +	Ma	Location *	WS
Category	Supplemental			GPS Latitude/Longitude	
				Start	End
Item	2015 USACE Erosion Survey, DRAFT			38.278145 °	38.277774 °
				-121.712609 °	-121.712137 °
DWR ID					
Action/Comments					
Inspector Comments: 2013 - Erosion pockets into the levee toe. 2015: Erosion pockets have increased in size. [2015 Site ID: CHS_22-5_R]

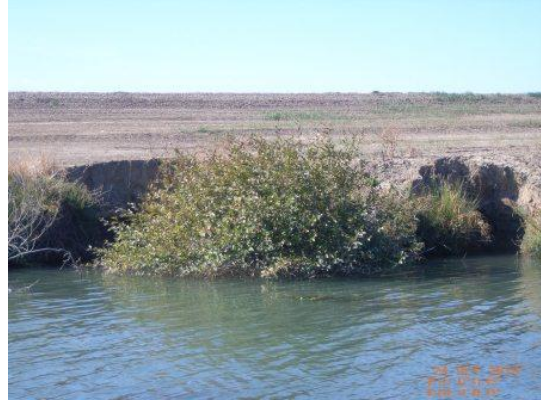
Photo 1 of 1 : USACE2013A_CHS_21-1_R_12.jpg

LM Start	3.78	Rating **	M	Issue No.	2
LM End	4.09	Issue Type +	Ma	Location *	WS
Category	Supplemental			GPS Latitude/Longitude	
				Start	End
Item	2015 USACE Erosion Survey, DRAFT			38.264585 °	38.260593 °
				-121.698868 °	-121.696403 °
DWR ID					
Action/Comments					
Inspector Comments: 2011 - Several pockets of erosion from rotational failure and slumping toe. 2013 - Site extended downstream to include new erosion pockets. 2015: No observed changes. [2015 Site ID: CHS_21-1_R]
